CLEARPATH®

UPDATING CLEARPATH GNSS RECEIVER TO v1.202

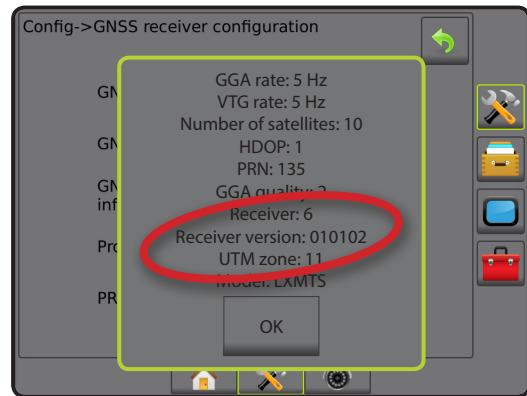
The best way to determine if your unit should be updated is to check the "Receiver" number and "Version" as shown. Go to Configuration->GNSS receiver configuration->GNSS status information and verify the values for "Receiver" and "Version".

This update should only be used when the "Receiver" is 6 or 7 and the Version is reported as 010102, 010105 or 010201. If your receiver is version 010016, you must first update to 010201 before proceeding with this latest update to 010202.

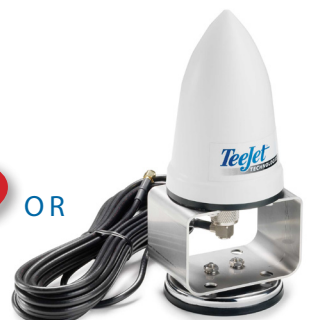
The GNSS antenna must be GLONASS capable if you intend to use GLONASS in the position solution. TeeJet's optional RXA-30 antenna is already GLONASS capable, but most Patch antennas sold with Matrix Pro GS consoles equipped with Receiver 6 GNSS receivers are GPS only, and will have to be replaced with GLONASS capable antennas in order to receive and apply GLONASS observations. Options include the RXA-30 antenna (part number 90-02720), and the GLONASS patch antenna (part number 78-50190).

REPLACE WITH
