CLEARPATH®

UPDATING CLEARPATH GNSS RECEIVER TO v1.202

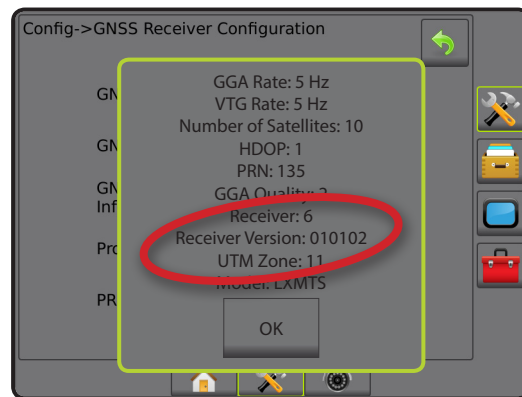
The best way to determine if your unit should be updated is to check the "Receiver" number and "Version" as shown. Go to Configuration->GNSS Receiver Configuration->GNSS Status Information and verify the values for "Receiver" and "Version".

This update should only be used when the "Receiver" is 6 or 7 and the Version is reported as 010102, 010105, or 010201. If your receiver is version 010016, you must first update to 010201 before proceeding with this latest update to 010202.
