# **GNSS UPDATES**

## FOR MATRIX GS & AEROS CONSOLES – APRIL, 2015

## **TECHNICAL UPDATE**

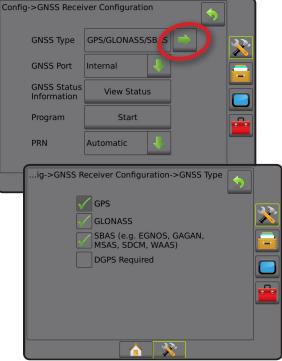
R X A - 30

d. The GNSS antenna must be GLONASS capable. TeeJet's optional RXA-30 antenna is already GLONASS capable, but most Patch antennas sold with Matrix Pro GS consoles equipped with Receiver 6 GNSS receivers are GPS only, and will have to be replaced with GLONASS capable antennas in order to receive and apply GLONASS observations. Options include the RXA-30 antenna mentioned above (part number 90-02720), and the GLONASS patch antenna (part number 78-50190).
