CLEARPATH®

UPDATING CLEARPATH GNSS RECEIVER TO v1.202

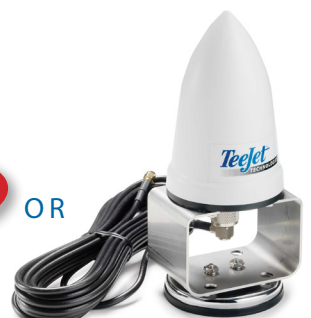
GNSS GLONASS PATCH

The GNSS antenna must be GLONASS capable if you intend to use GLONASS in the position solution. TeeJet's optional RXA-30 antenna is already GLONASS capable, but most Patch antennas sold with Matrix Pro GS consoles equipped with Receiver 6 GNSS receivers are GPS only, and will have to be replaced with GLONASS capable antennas in order to receive and apply GLONASS observations. Options include the RXA-30 antenna (part number 90-02720), and the GLONASS patch antenna (part number 78-50190).

REPLACE WITH
