# GNSS UPDATES

## FOR MATRIX GS & AEROS CONSOLES – APRIL, 2015

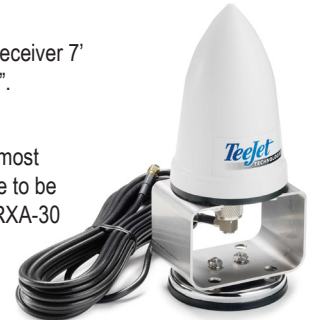
- d. The GNSS antenna must be GLONASS capable. TeeJet’s optional RXA-30 antenna is already GLONASS capable, but most Patch antennas sold with Matrix Pro GS consoles equipped with Receiver 6 GNSS receivers are GPS only, and will have to be replaced with GLONASS capable antennas in order to receive and apply GLONASS observations. Options include the RXA-30 antenna mentioned above (part number 90-02720), and the GLONASS patch antenna (part number 78-50190).  
*NOTE: The cost for antenna replacement is not covered by TeeJet Technologies.*
